6
National Dam Inspection Program - Big Brown Dam.
SUSQUEHANNA RIVER BASIN,
BROWNS RUN, CAMBRIA COUNTY

BIG BROWN DAM

(NDI I.D. NO: PA-00502,
DER I.D. NO: 11-1)
Number

PHASE I INSPECTION REPORT
NATIONAL DAM INSPECTION PROGRAM

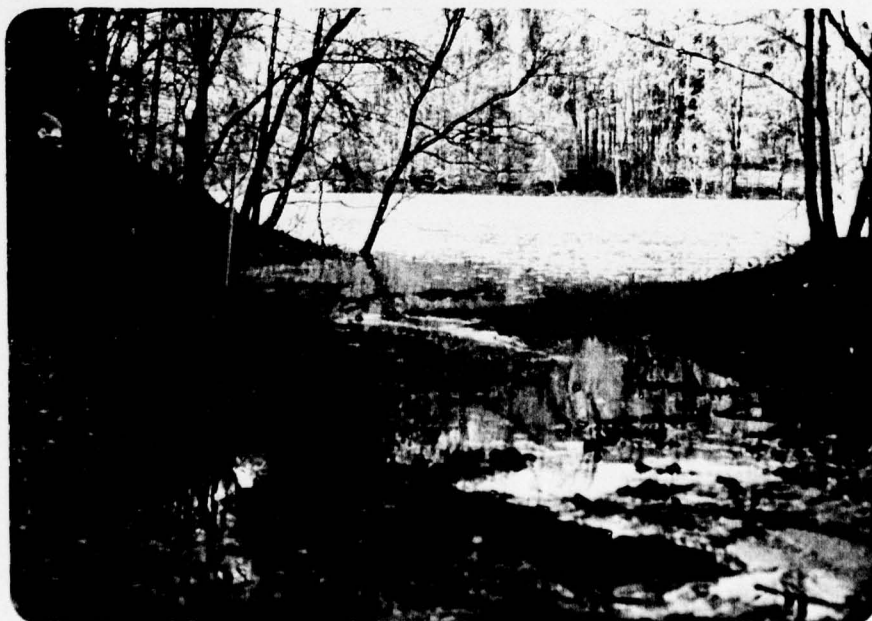
Photograph No. 2
Emergency spillway approach channel.

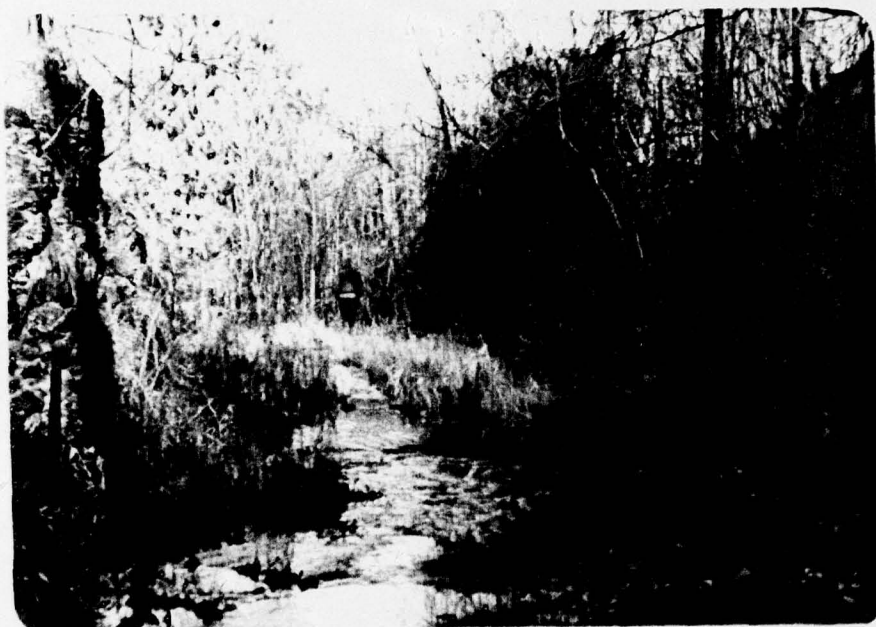
Photograph No. 3

VISUAL EXAMINATION OF	OBSERVATIONS	REMARKS OR RECOMMENDATIONS
CONCRETE WEIR	The emergency spillway has no overflow weir structure.	
APPROACH CHANNEL	Lake. Free of debris.	
DISCHARGE CHANNEL	Rock-cut channel. In good condition.	
BRIDGE AND PIERS	None

Emergency spillway control section and discharge channel.

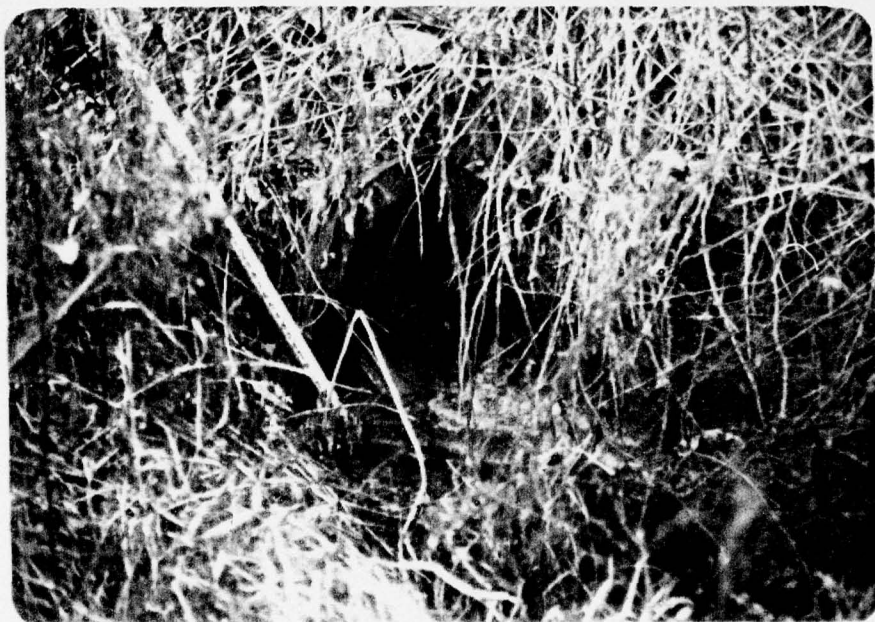
VISUAL EXAMINATION OF CRACKING AND SPALLING OF CONCRETE SURFACES IN OUTLET CONDUIT	OBSERVATIONS	REMARKS OR RECOMMENDATIONS
	(The outlet facilities were not accessible for inspection.)	
INTAKE STRUCTURE	Submerged	
OUTLET STRUCTURE	The outlet pipe directly discharges into an earth channel. There is no outlet structure.	
OUTLET CHANNEL	In fair condition.	
EMERGENCY GATE	The water authority personnel reported that the operational condition of the reservoir blow-off valve was questionable. The operational condition of this valve was not observed.	The operational condition of the blow-off valve and other outlet facilities should be reevaluated and necessary maintenance performed.

Photograph No. 5
Primary spillway outlet pipe.

2. The structural and operational condition of the outlet facilities should be evaluated and necessary maintenance performed.
3. The crest of the embankment should be surveyed and low spots filled to design elevation.

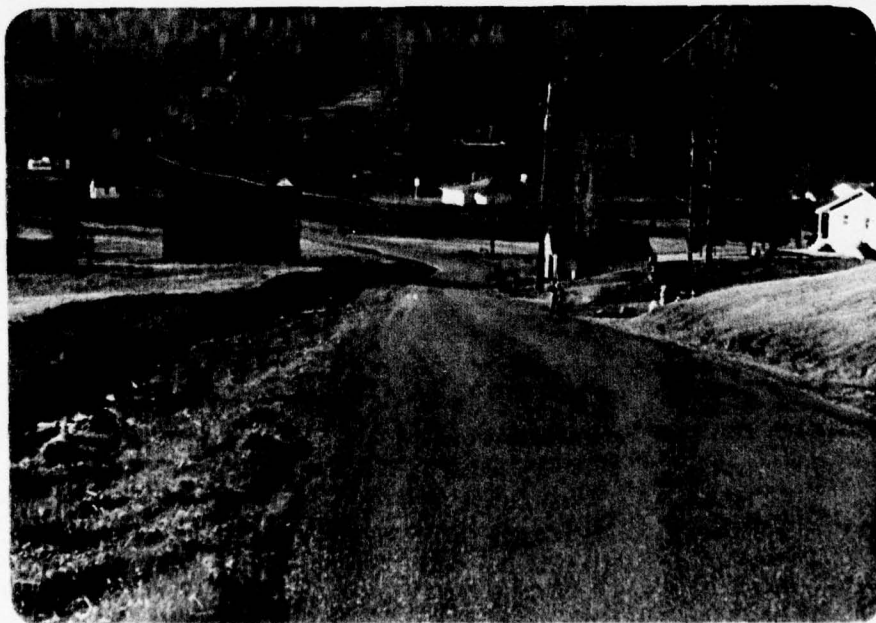
e. Downstream Channel. Downstream from the dam, Brown's Run flows through a narrow, uninhabited valley for about one mile where it enters a residential area. Further downstream, Brown's Run flows through other residential areas near Spangler, Pennsylvania, where it joins the West Branch of the Susquehanna River approximately 2-1/2 miles downstream from the dam. A further description of the downstream conditions is included in Section 1.2d.

Photograph No. 6
Flood plain (Mile 1.0). Brown Run flowing
left to right.

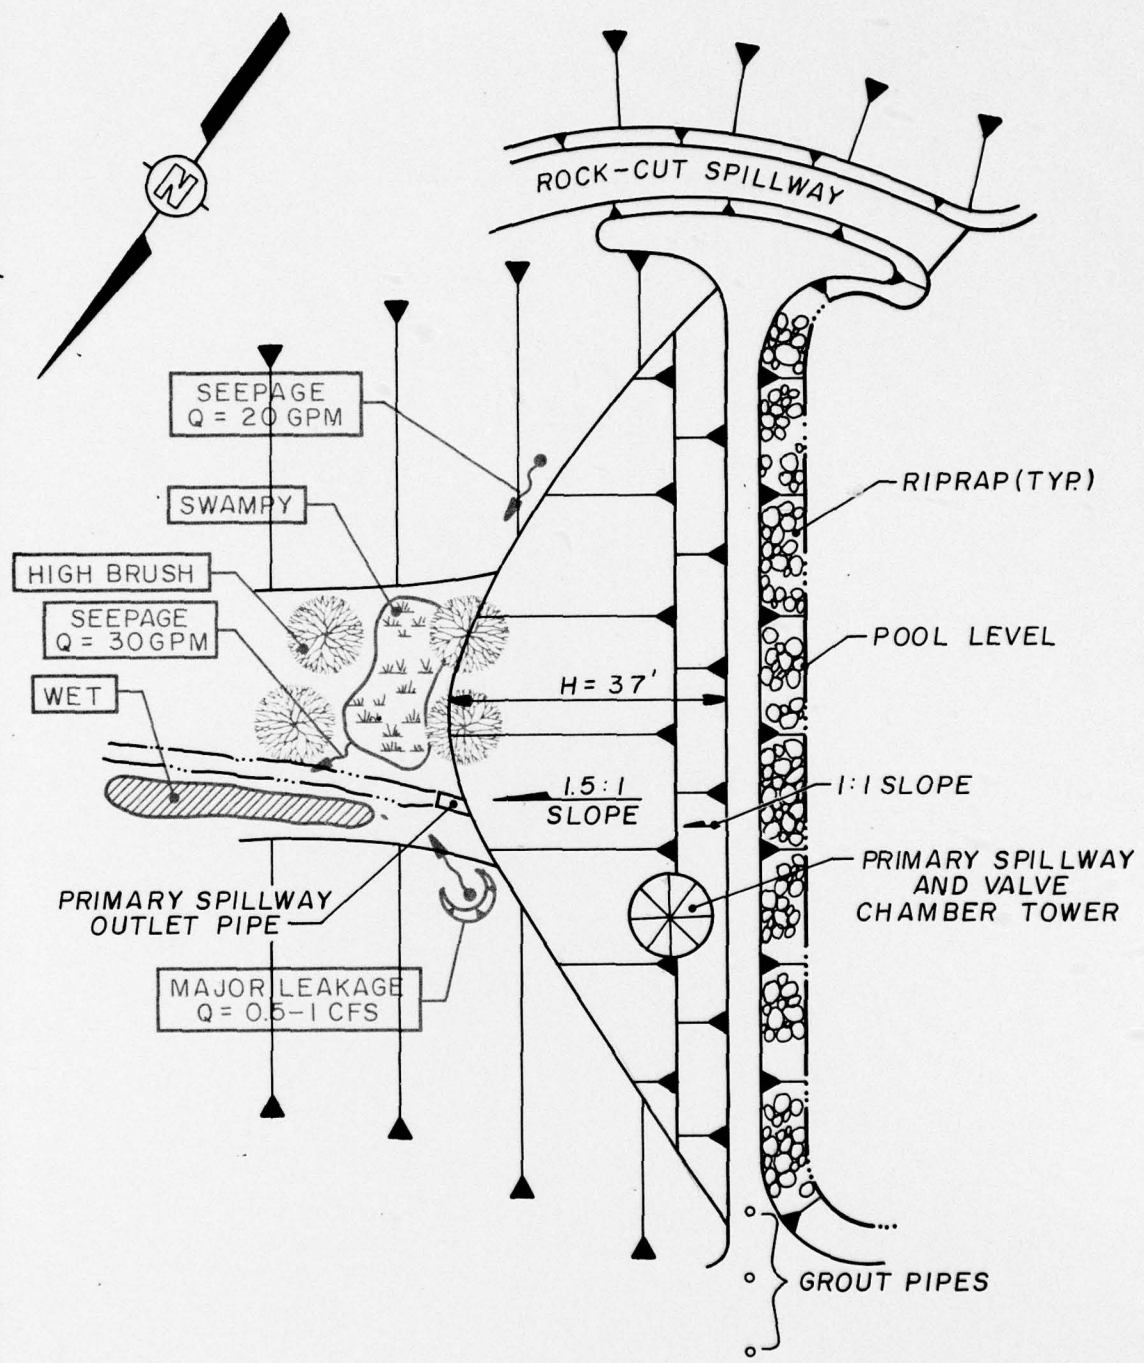
The most significant condition noted at the dam site was the presence of extensive swampy areas immediately below the toe of the dam. Ground in this area was found to be very soft. It appears that this swampy condition is caused by flow discharging into this area from the right abutment and underseepage. The flow from the right abutment seepage point was estimated to be on the order of 20 gallons per minute. This seepage point is located at the abutment/embankment interface about midheight of the dam. Flow from the swampy areas along the toe of the dam discharges into the primary spillway discharge channel through a small stream. Flow in this stream was estimated to be on the order of 30 gallons per minute. The flow at the major leakage point on the left abutment, which was reported to have existed since the completion of the dam, was estimated to be on the order of one-half to one cfs. Flow from the seepage points was found to be clear, showing no signs of internal erosion.

VISUAL EXAMINATION OF	OBSERVATIONS	REMARKS OR RECOMMENDATIONS
JUNCTION OF EMBANKMENT AND ABUTMENT, SPILLWAY AND DAM	No signs of distress other than the seepage condition described below and shown in Plate 5.	
ANY NOTICEABLE SEEPAGE	A significant seepage point is located near the left abutment/embankment interface. The discharge is estimated to be one-half to one cfs. See Plate 5 for other seepage points and wet and swampy areas below the toe of the dam.	This seepage should be monitored.
STAFF GAGE AND RECORDER	An inclined pipe with elevation markers serves as a staff gage. There is no recorder.	
DRAINS	None

- a. Controlling swampy conditions at the downstream toe of the dam and evaluating the stability of the embankment in view of these conditions. The detailed evaluation of the dam should include, but not be limited to, subsurface investigations, material testing, and seepage and stability analyses.

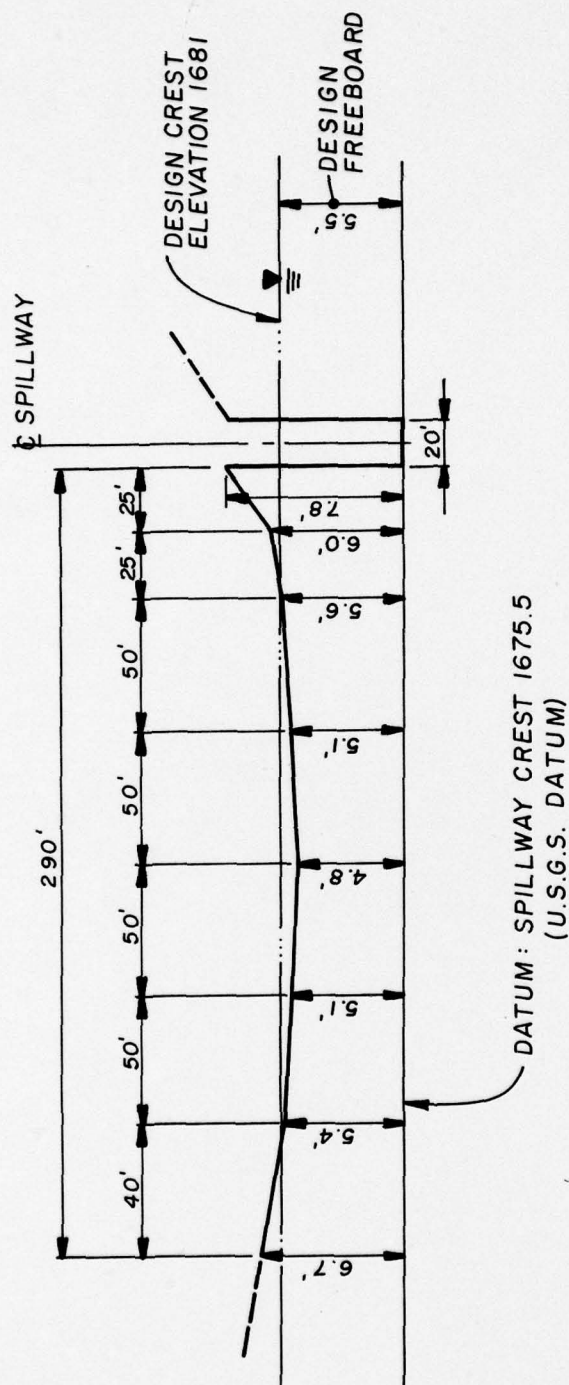
DAM CREST PROFILE (LOOKING DOWNSTREAM)

one vertical; on the remaining portions the slope was reasonably within the design slope of one and one-half horizontal to one vertical. The crest of the dam was surveyed relative to the emergency spillway crest elevation and was found to be generally below the design crest elevation. The crest profile of the dam is illustrated in Plate 6.
